# ATTEMPTED THEFT — PREVENTED

Steel pipe yard, Mundka Industrial Area, Delhi · 23 May 2026 · 04:16 – 04:55 IST

SPS-IR-2026-0523-014

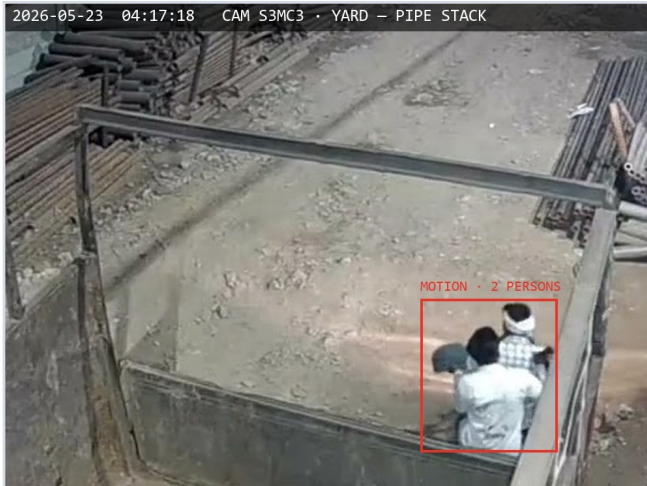
Still 1 — 04:17:18, camera S3MC3. Two persons at the pipe stack, boxed by the detection zone.

- Entry was over the north-east rear wall, the one side of the yard without lighting. The camera covered it; the intruders evidently assumed it did not.
- The voice warning ended the attempt within 30 seconds of the first movement. No physical intervention was needed.
- Nothing was taken. The pipe stacks nearest the wall were checked by the patrol against the previous evening's count.

| SPS | Detection zone extended 2 m along the rear wall; sensitivity re-tuned for that camera. Done 23 May. |
| CLIENT | Recommended: one floodlight on the north-east corner (any 50 W LED on the existing supply). Reduces repeat attempts more than any equipment we can add. |

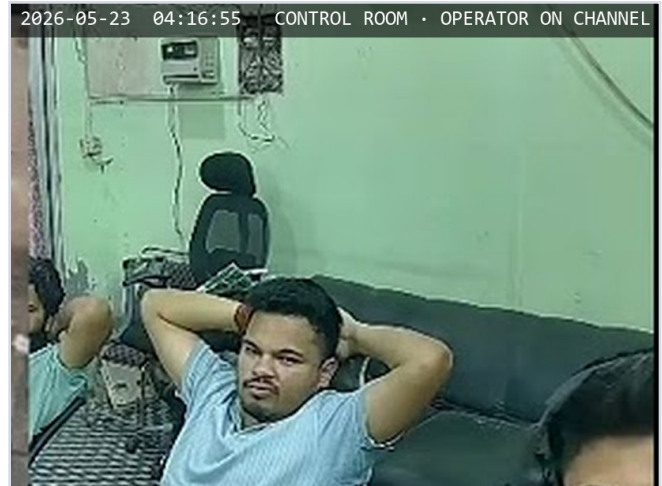
Still 2 — 04:16:55, control room. Operator on channel, live feed verified.
